SUBJECT: A machine operator died when his glove caught in a wire drawing machine.

SUMMARY
California FACE Report #02CA009

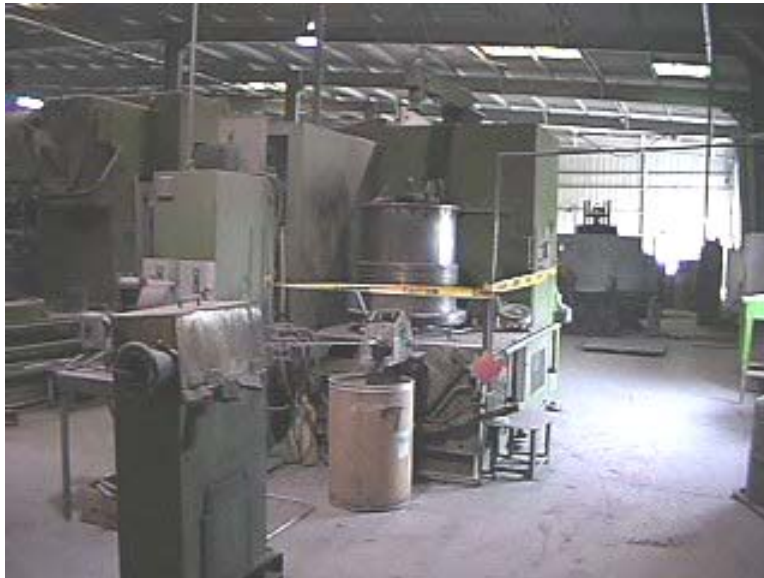
Exhibit #1

The site of the incident was a large industrial machine shop that spooled wire after drawing it through dies to reduce it to specific diameters. The machine used to complete this process was called a "wire drawing" or "wire pulling" machine (**exhibits #1 & #2**). The machine took larger size diameter wire and pulled it through sets of dies to reduce its diameter to a desired size. The pulling mechanism on the machine was a drum (**exhibits #3 & #4**). The operator fed the wire through the dies and a safety stop bar (**exhibit #7**), and then wrapped the wire around the drum. The drum would then rotate pulling the wire through the sets of predetermined dies (**exhibit #1**). As the drum continued to rotate, the wire was fed off the top of the drum through directional guides and into the spooling mechanism. It then spooled the finished wire onto a wire holding device (**exhibit #2**). The wire holding device was then removed from the machine and the finished product would then be stored or shipped.

View of the wire pulling machine and reducing dies.

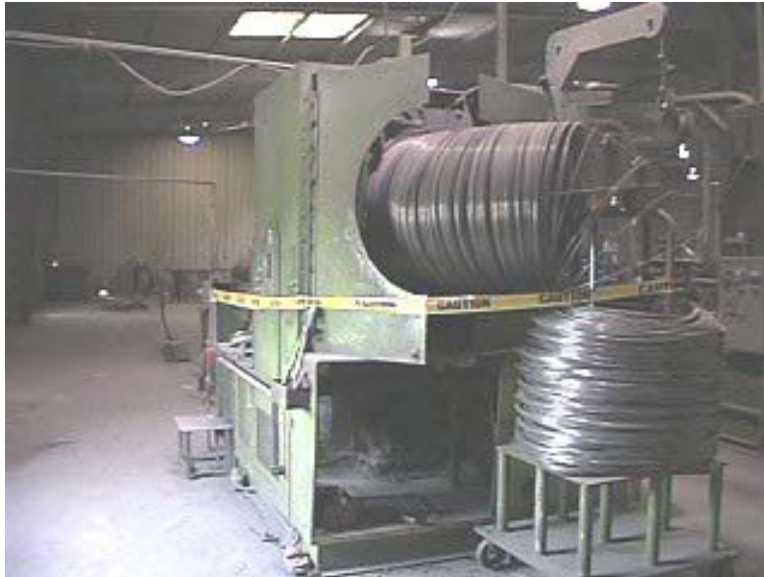
Exhibit #2

View of the wire pulling machine and the wire holding device.

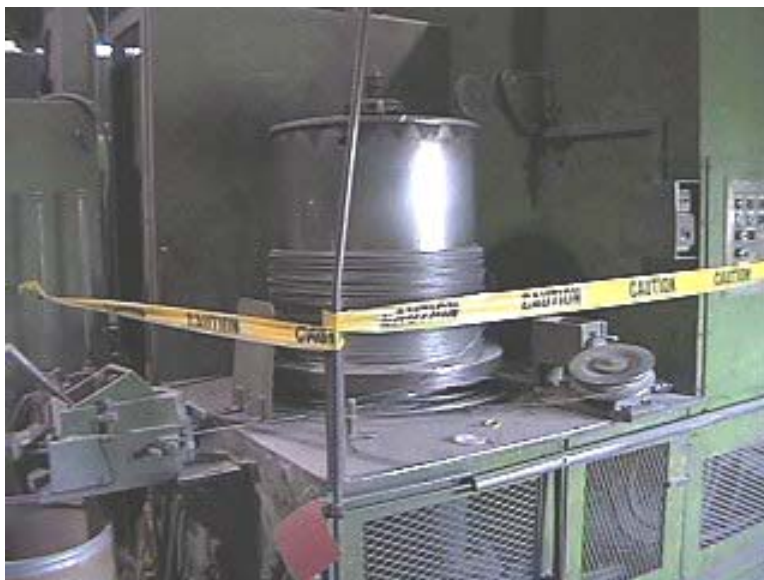
Exhibit #3

The paramedics and police arrived within minutes. CPR was administered and continued while the victim was transported to the hospital. The victim failed to regain consciousness or spontaneous respirations and was pronounced dead at the hospital. Examination of the incident site revealed that the victim reached into the area of the rotating drum and got his glove caught in the wire. This action pulled him into the machine between the drum and the machine housing.

View of the rotating drum the victim got caught in.

Recommendation #1: Ensure that all machines are properly guarded.

Discussion: Machines that have moving parts that can create a hazard for employees should be guarded. Guarding protects the employee from getting caught in moving parts and protects the machine. Had proper guards been in place on this machine, this incident might have been prevented.

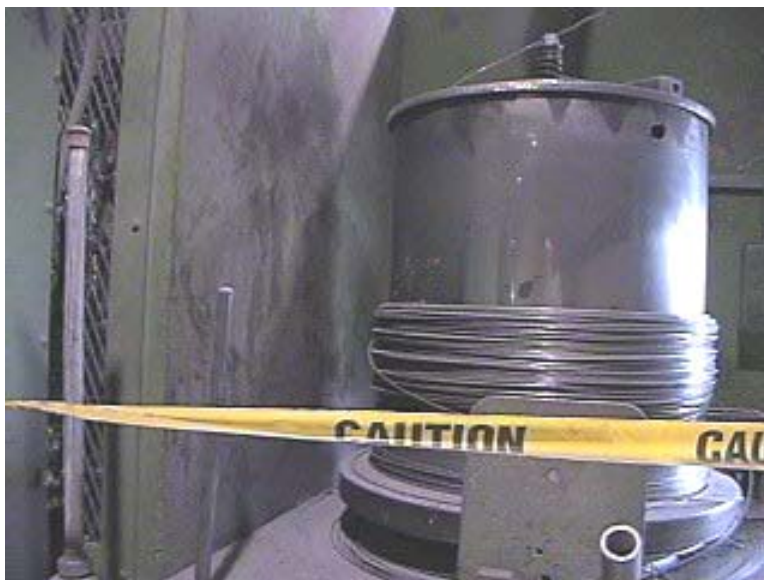
Exhibit #4

View of the rotating drum showing the area where the victim got pulled into.

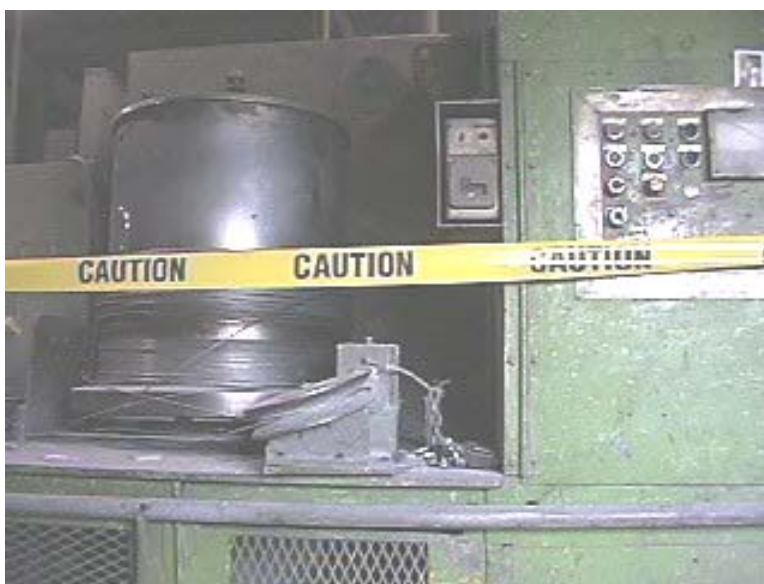
Exhibit #5

View of the rotating drum in proximity to the machine control panel.

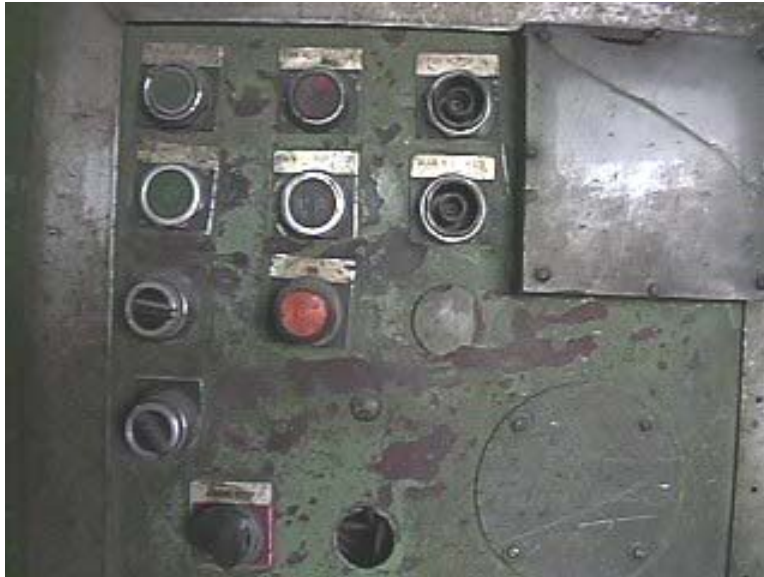
Exhibit #6

View of the machine control panel

Recommendation #3: Ensure that all emergency shut off devices and switches on machines are properly installed, maintained in working condition, and properly labeled so the operator can identify them in an emergency.

Discussion: The machine involved in this incident had a safety bar that should have automatically shut off the machine when the operator applied pressure to it. This device was non-operative and wired to the face of the machine. The control panel on this machine did not have proper identifying markings on the control buttons to designate their emergency shut off function. When controls are not properly marked the wrong button could be pushed by mistake. Improperly installed, non-functional, or mislabeled safety devices could contribute to an accident. Workers should not be allowed to operate machines that have identified hazards such as disabled and improperly labeled emergency shut off switches.

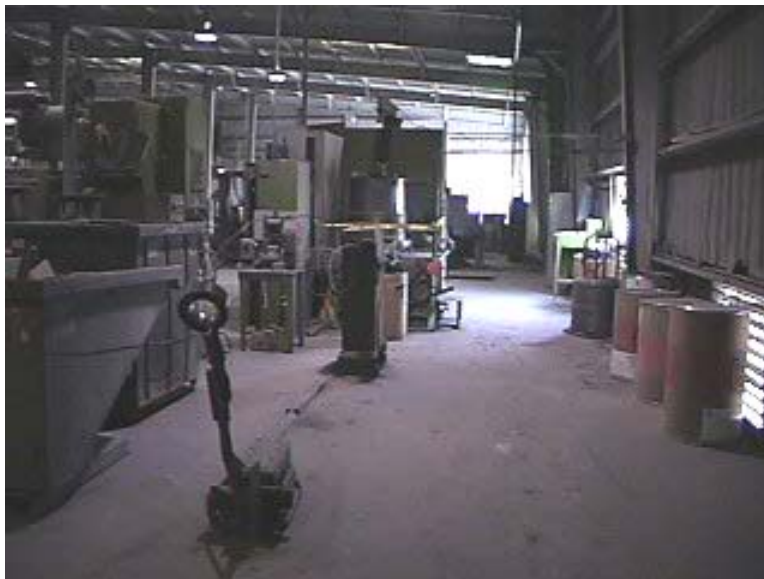
Exhibit #7

View of the safety bar the wire goes through before the dies.

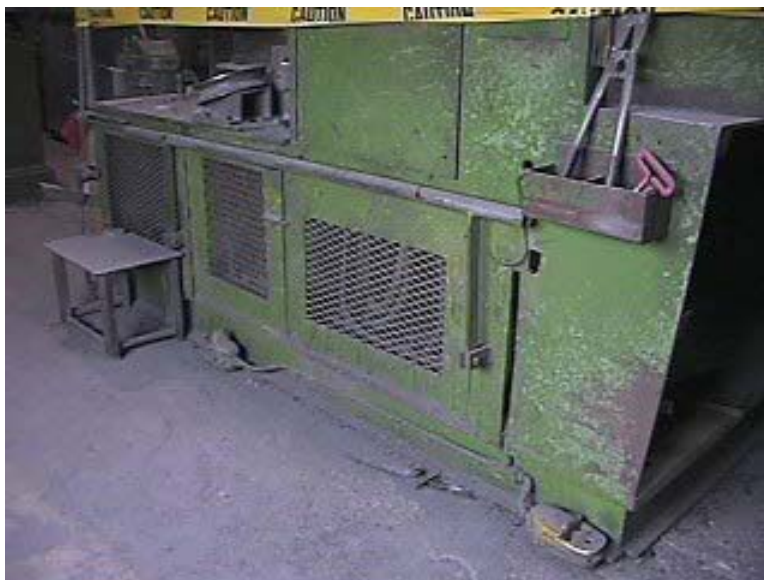
Exhibit #8

The machine had a safety stop bar hinged across the front of the machine that had been disconnected (**exhibit #8**). The bar was designed to prevent personal injury by shutting off the power to the machine when pressure was applied to it. If a worker were pulled into the machine, pressure caused by the worker's body against the safety stop bar would shut off the machine. The machine had no identifying marks to indicate its brand name, serial number or age.

View of the inoperative safety bar wired to the machine.
